**FINAL  
FIRST  
FIVE-YEAR REVIEW OF RECORD OF DECISION  
FOR  
MARBO ANNEX OPERABLE UNIT**

**ANDERSEN AIR FORCE BASE, GUAM**

**July 2004**

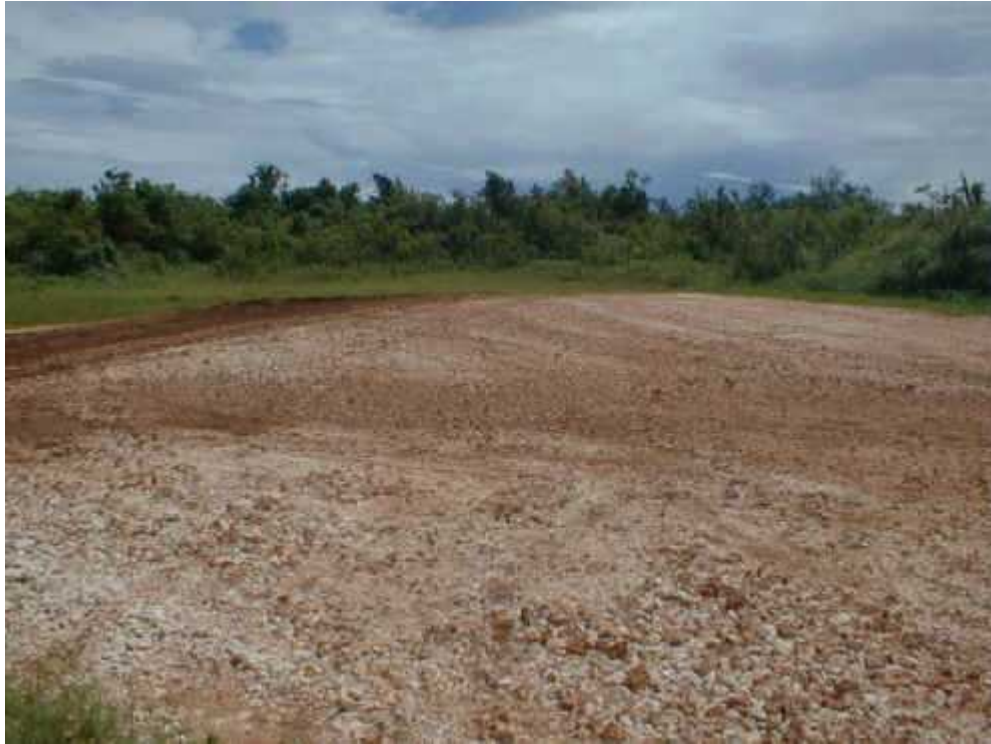
Photo 3-1 Area 2 at Waste Pile 6 After Completion of Remedial Action During February 2004 Site Inspection.

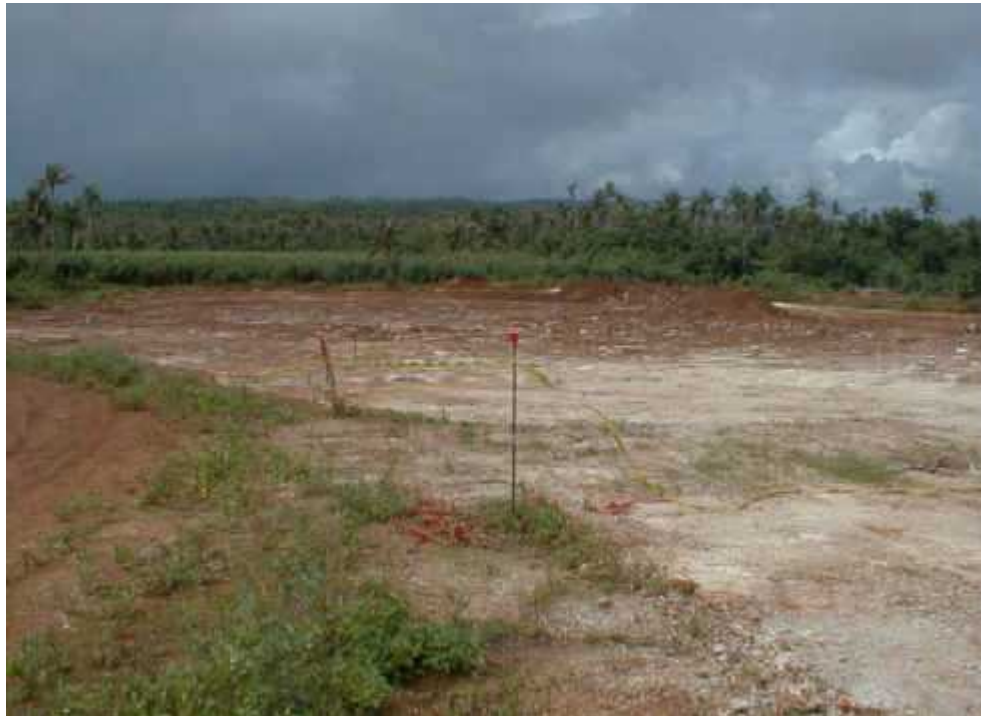
Photo 3-2 Area 4 at Waste Pile 6 After Completion of Remedial Action During February 2004 Site Inspection.

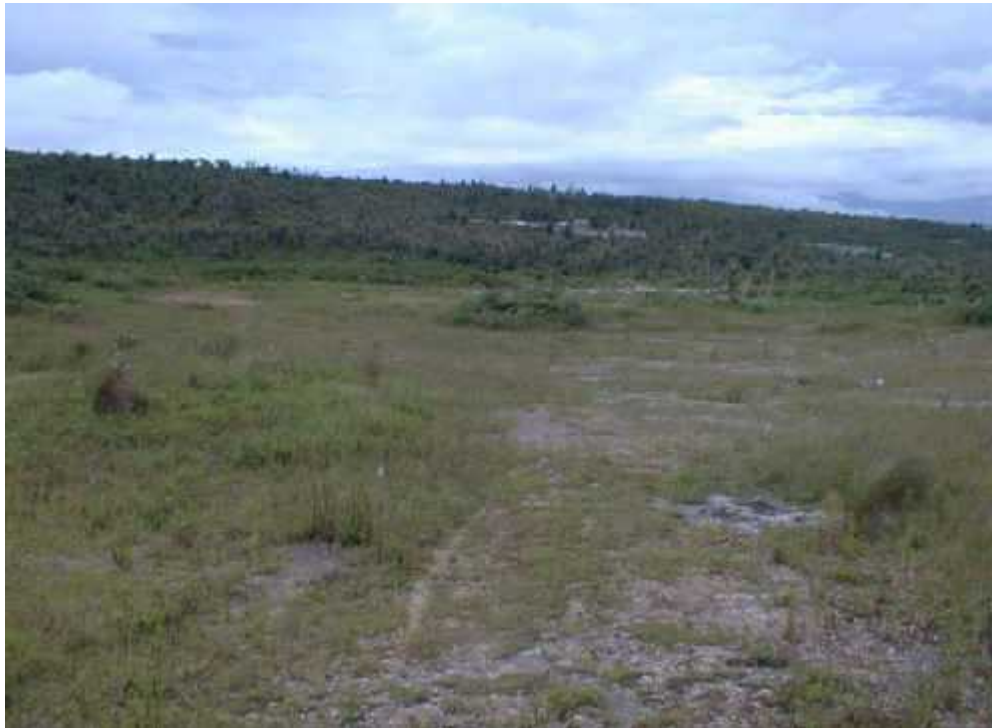
The inspection team walked through the site and examined the excavated areas at Landfill 29 and found that the project objective has been met. The COC-impacted soil and associated debris have all been removed from the site and Landfill 29 has been properly restored requiring no further remedial action (Photo 3-3).

Photo 3-3 Landfill 29 After Completion of Remedial Action During February 2004 Site Inspection.

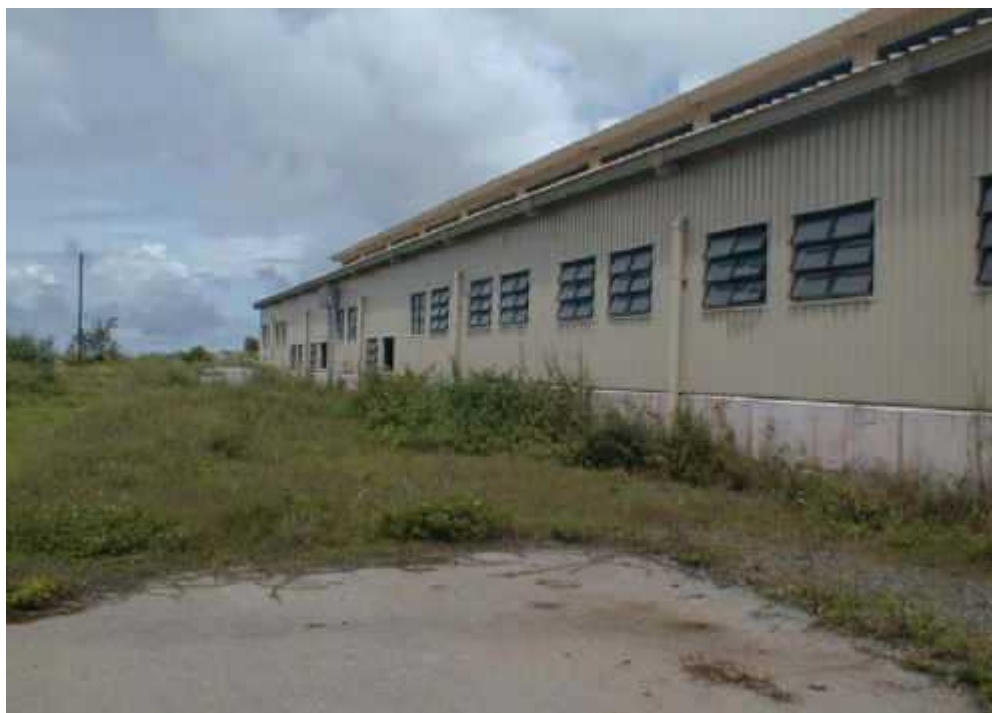
The inspection team walked through the site and examined the excavated areas at MARBO Laundry and found that the project objective had been met. The COC-impacted soil and associated debris have all been removed from the site and MARBO Laundry has been properly restored requiring no further remedial action (Photos 3-4 through 3-6).

Photo 3-4 South Side of MARBO Laundry After Completion of Remedial Action During February 2004 Site Inspection.

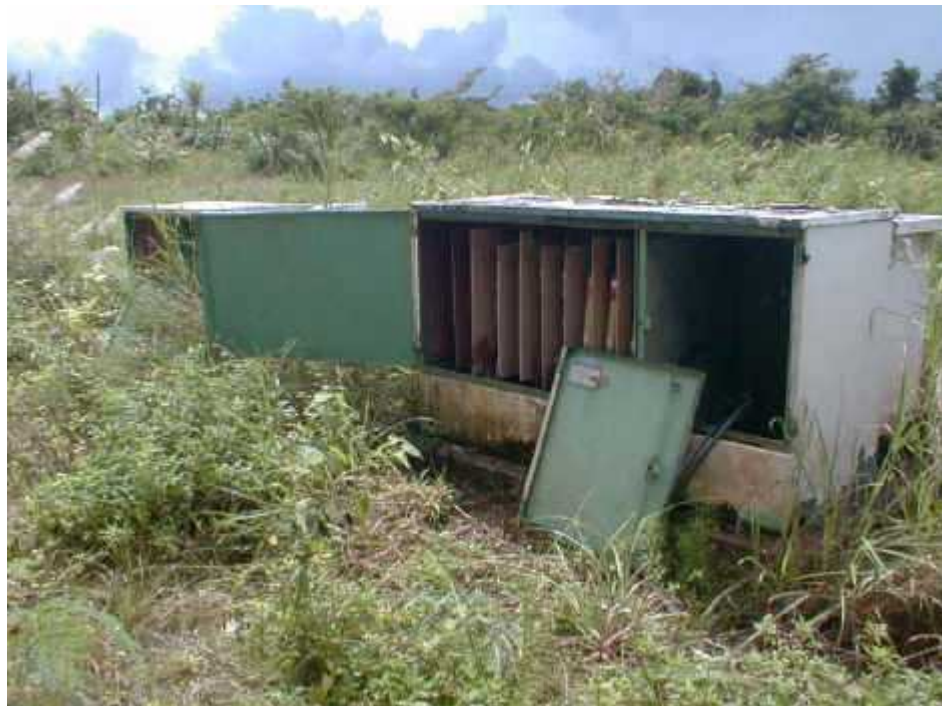
Photo 3-6 Remnant of Former Transformer at MARBO Laundry After Completion of Remedial Action During February 2004 Site Inspection.

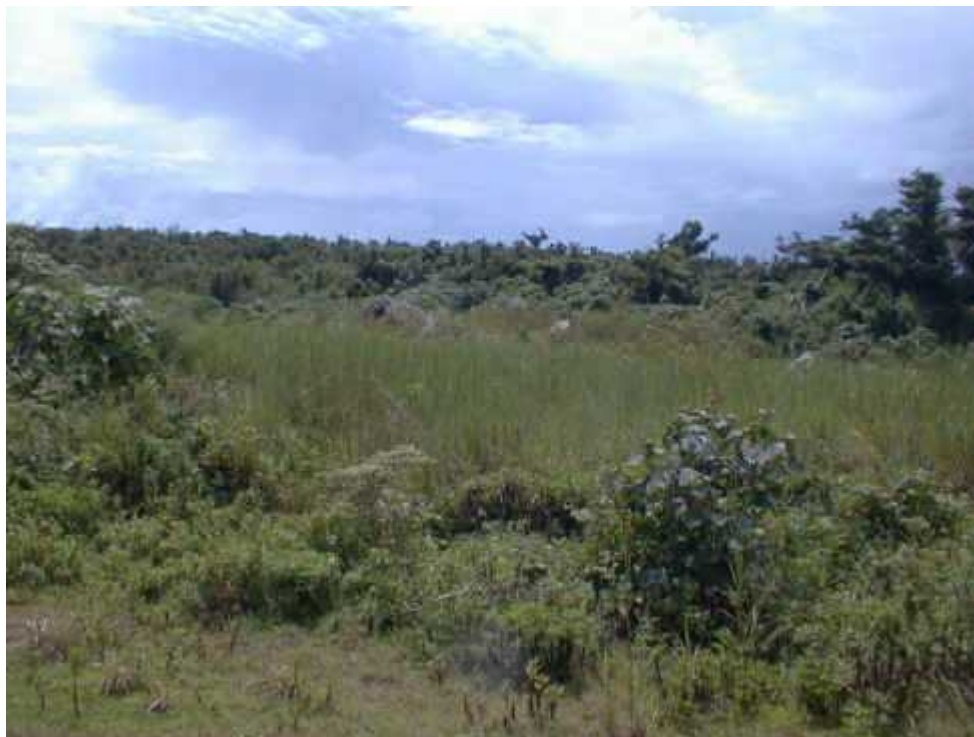
The inspection team walked through the site and examined the excavated areas at Waste Pile 7 and found that, for the most part, the soil cover, the riprap, and the ponding basin at Waste Pile 7 were intact (Photos 4-1 and 4-2). However, according to the last site inspection on 22 April 2004, the upper 6 inches of the *Soil Cover* and the re-vegetation are damaged by a small pig wallow and rainfall (Photo 4-3), and also by growth of small trees (Photo 4-4). Additionally, there were signs of truck traffic at the site and no warning signs were observed around the site to warn against intrusive activities such as driving, trenching, or excavation at the site (Photos 4-5 and 4-6).

Photo 4-1 Waste Pile 7 After Completion of Remedial Action During February 2004 Site Inspection.

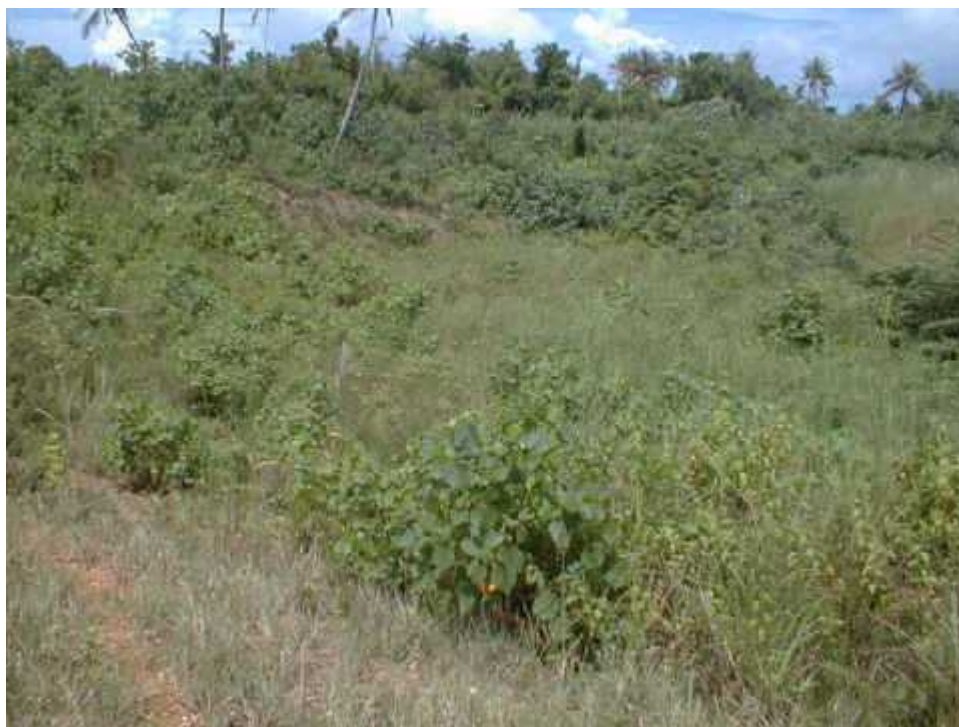
Photo 4-2 Waste Pile 7 Drainage Area After Completion of Remedial Action During February 2004 Site Inspection.

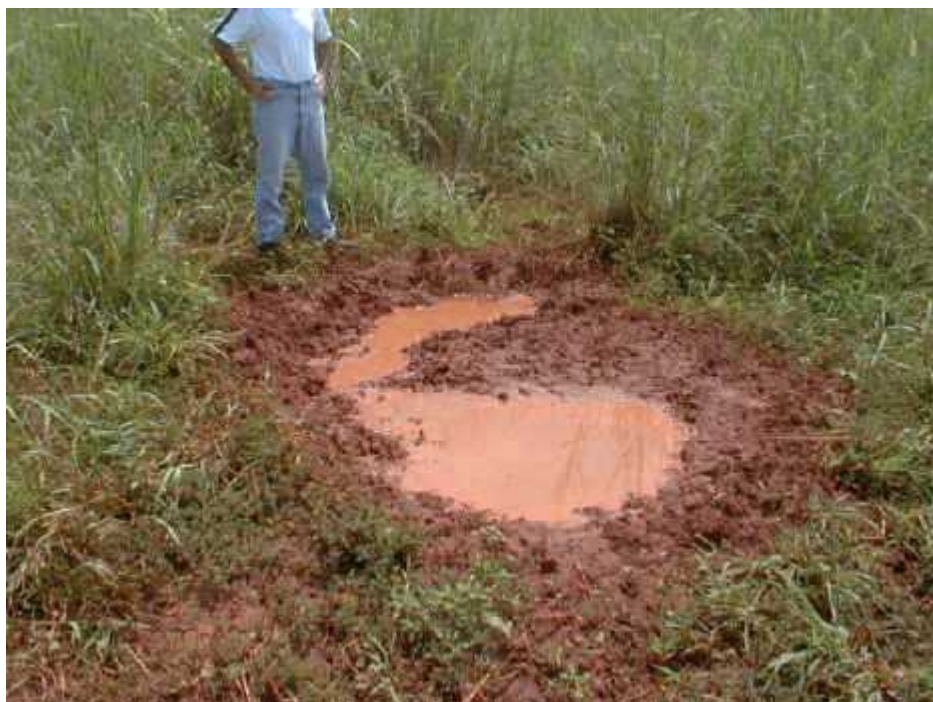
The soil cover for Waste Pile 7 was properly installed in the spring of 2000. However, as the report notes, and as EPA observed during the field inspection in February, 2004, a wild pig has wallowed at the site. While the wallow did not breach the cover and has been successfully repaired, such activities do pose an increased risk for a breaching of the cover in the future. As suggested in the Five-Year Review, the Operations and Maintenance (O&M) plan for this site should be amended to include quarterly monitoring of the cover integrity, with repairs as necessary. Also as suggested in the Five-Year review, warning notices should be posted to implement the institutional controls specified in the ROD.

Based on the site inspection, the integrity of the *Soil Cover* is starting to deteriorate and if allowed to continue, the *Soil Cover* may not be protective of the human health or the environment.

Photo 4-3 Soil Cover Damaged by Pig Wallow at Waste Pile 7 After Completion of Remedial Action During February 2004 Site Inspection.

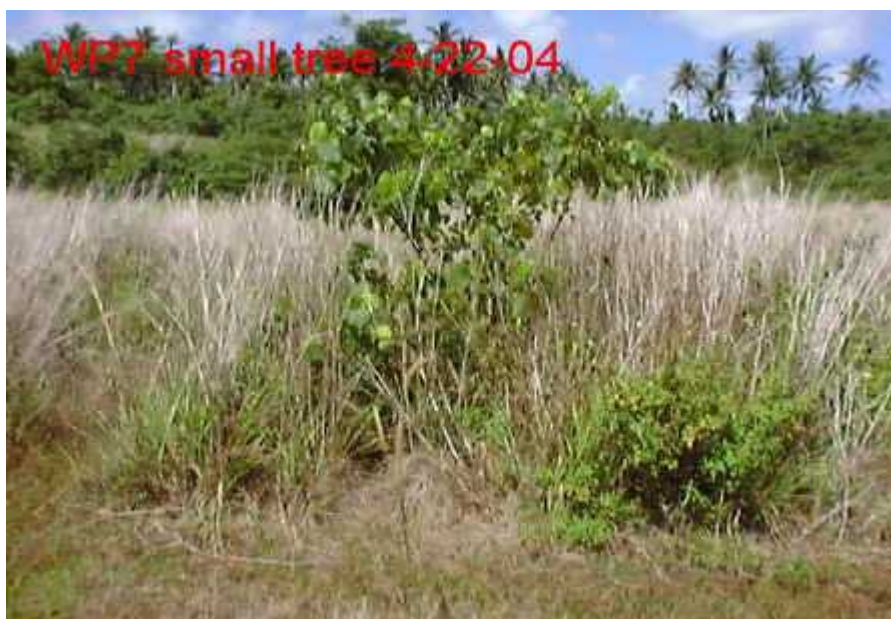
Photo 4-4 Small Tree Growing on Soil Cover at Waste Pile 7 After Completion of Remedial Action During February 2004 Site Inspection.

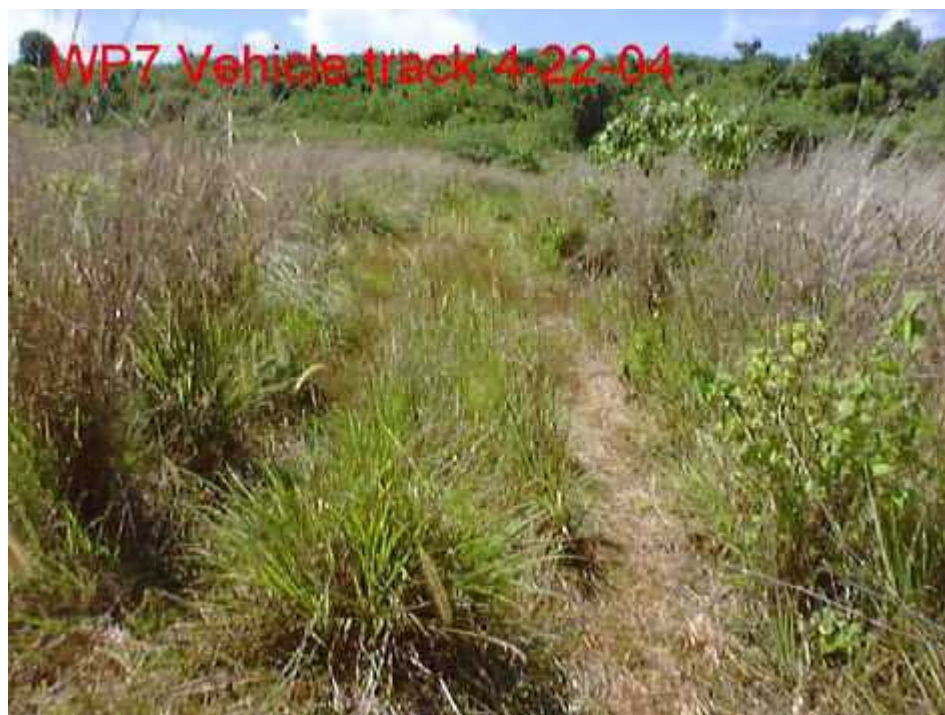
Photo 4-5 Sign of Truck Traffic at Waste Pile 7 After Completion of Remedial Action During February 2004 Site Inspection.

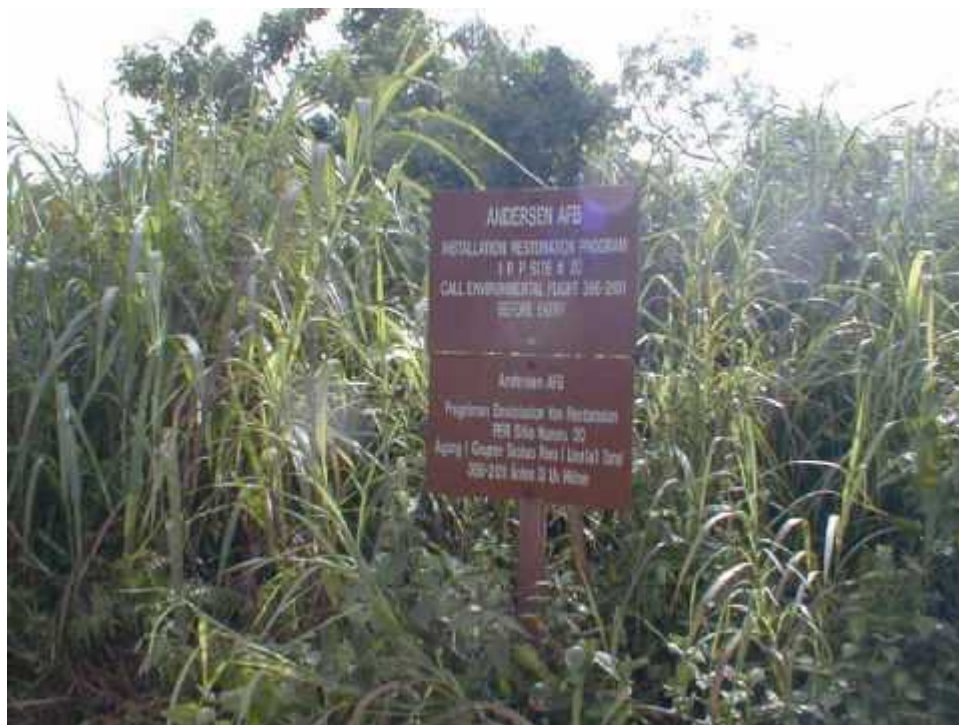
Photo 4-6 Waste Pile 7 Entrance Sign During February 2004 Site Inspection.
